EXPLOSIVE SIZING OF 70-INCH DIAMETER WELDED
ALUMINUM PREFORMS FROM 5086, 2014 T4 AND
2014 T6 MATERIAL

NATIONAL AERONAUTICS and SPACE ADMINISTRATION
GEORGE C. MARSHALL SPACE FLIGHT CENTER
HUNTSVILLE, ALABAMA

Report No. 62B057
16 April 1962

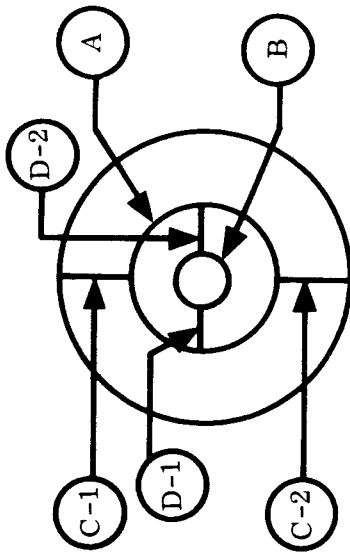
WELD QUALITY BEFORE FORMING			WELD QUALITY AFTER FORMING	
WELD	INSP. METHOD	REPAIR	INSP. METHOD	QUALITY AND COMMENTS
PREFORM #1				
A	V, D, X	Extensive	V	Fractured and cracked longitudinally
B	V, D, X	Extensive	V	Sound
C-1	V, D, X	2 Spots	V	Fractured longitudinally, through repairs
C-2	V, D, X	None	V, X	A-1, Class I
D-1	V, D, X	None	V, X	Two (2) short transverse cracks
D-2	V, D, X	None	V, X	Two (2) short transverse cracks
PREFORM #2				
A	V, D, X	Extensive	V	Fractured and cracked longitudinally
B	V, D, X	Extensive	V	Sound - Border line
C-1	V, D, X	None	V	Sound
C-2	V, D, X	None	V	Sound
D-1	V, D, X	None	V	Two (2) short transverse cracks
D-2	V, D, X	None	V	Sound
